Jordan Road Area CCTV Inspection Analysis

PREPARED BY: CH2M

DATE: March 31, 2017

PROJECT NUMBER: 690666

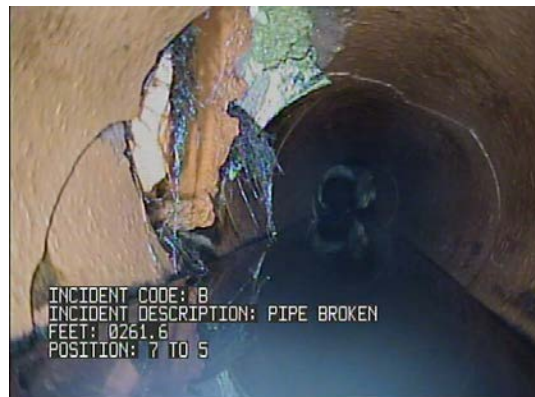
Broken Pipe – One type of structural problem observed was broken pipe segments with visible voids behind the break. A broken pipe section seen during CCTV inspection is shown in Figure 1. Breaks may be the result of excessive loading, improper installation, or pipe deterioration. These defects may allow leakage of raw sewage into the ground and significant inflow of groundwater which may cause sinkholes.

Figure 1
Broken Pipe in Segment MH 54 to MH 53

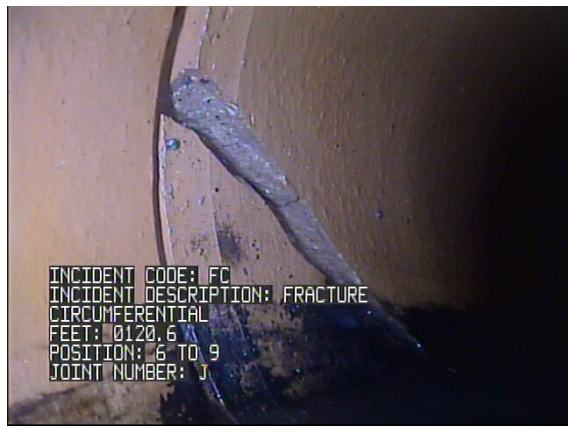
Figure 2 shows a fractured pipe section. Fractures are defects where there is a clear separation between the fragments, but no hole has yet been formed. Like breaks, fractures may be the result of excessive loading, improper installation, or pipe deterioration. Left unabated, fractures can worsen over time to cause pipe deflection and collapse.

Figure 2
Fractured Pipe in Segment MH 49 to MH 48

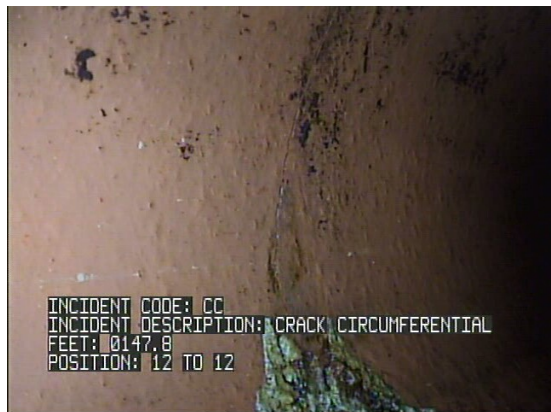
Cracked Pipe – Figure 3 shows a crack in a pipe segment wall. Cracks are less severe than fractures, and do not have visible separation between the pieces. Over time, however, cracks can worsen into fractures and breaks.

Figure 3
Cracked Pipe in Segment MH 53 to MH 52

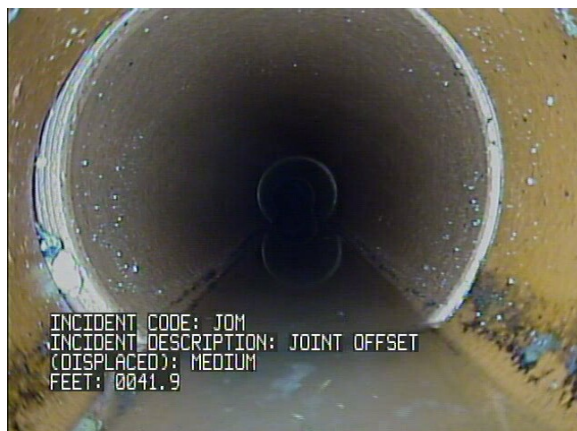
Offset Joints – Offset joints between pipe segments can allow groundwater infiltration to occur, will contribute to uneven stresses on the pipe, and can cause further cracks and damage. This defect is considered structural and is evaluated accordingly. Figure 4 shows an example of a separated joint

Figure 4
Offset Joint in Segment MH 68 to MH 65

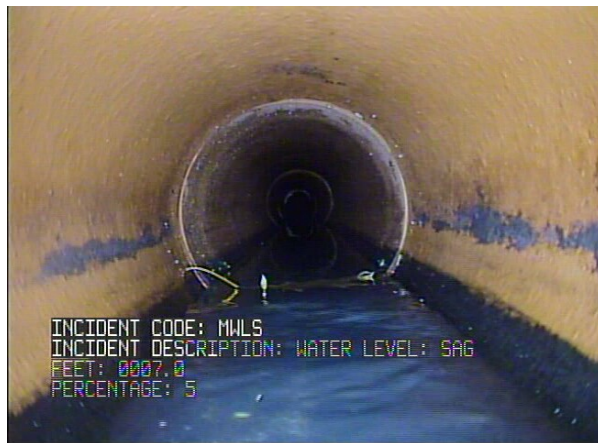
Vertical Alignment Defects – Several severe vertical alignment defects were recorded during the inspection process. This type of defect creates hydraulic bottlenecks which reduce the system’s hydraulic carrying capacity and causes high water levels within the pipe segment. Some of the abandoned inspections were associated with this type of defect. Figure 5 shows flow conditions prior to a survey being abandoned because of a vertical alignment defect.

Figure 5
Sag in Pipe Segment MH 49 to MH 48

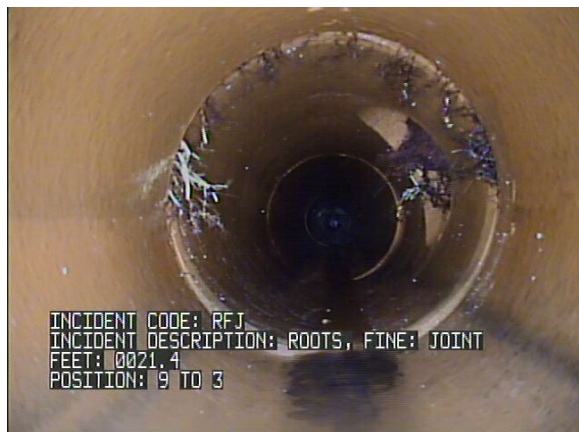
Roots – Another observed problem was light to heavy root intrusion. In some cases, heavy roots impeded the travel of the CCTV camera. Roots are a maintenance problem and must be removed through cleaning and cutting activities or chemical treatment. Roots may also cause structural damage to pipe joints and walls by growing and forcing cracks to open, requiring pipe replacement. Intrusion of roots at joints is shown in Figure 6.

Figure 6
Root Intrusion in Segment MH 66 to MH 65

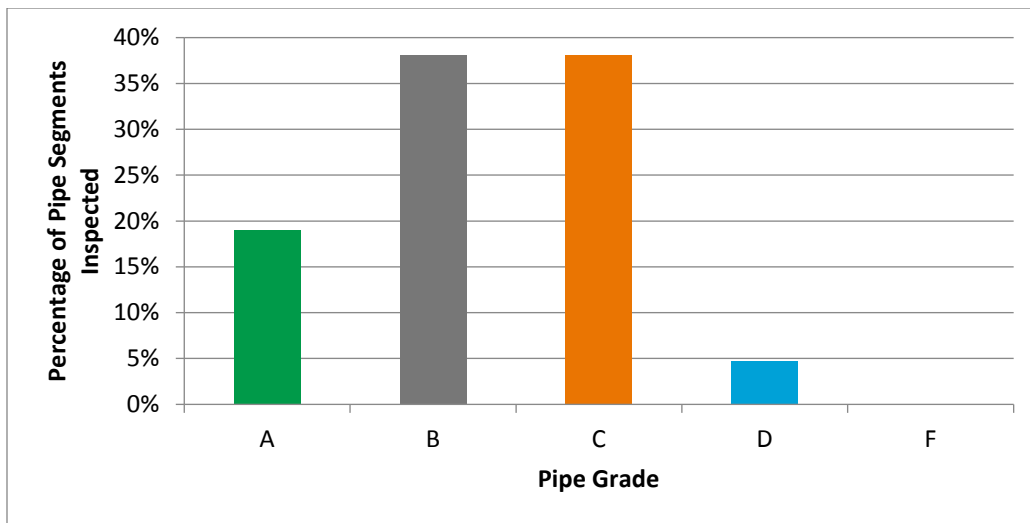
Figure 7
Pipe Grade Distribution

The percentages of pipe segments in each of the condition grades for the pipes inspected in 2016 are listed below. Figure 7 shows the graphical representation of the distribution of the pipe segments based on overall condition grade.

- 19 percent of pipes are in Grade A condition
- 38 percent of pipes are in Grade B condition
- 38 percent of pipes are in Grade C condition
- 5 percent of pipes are in Grade D condition

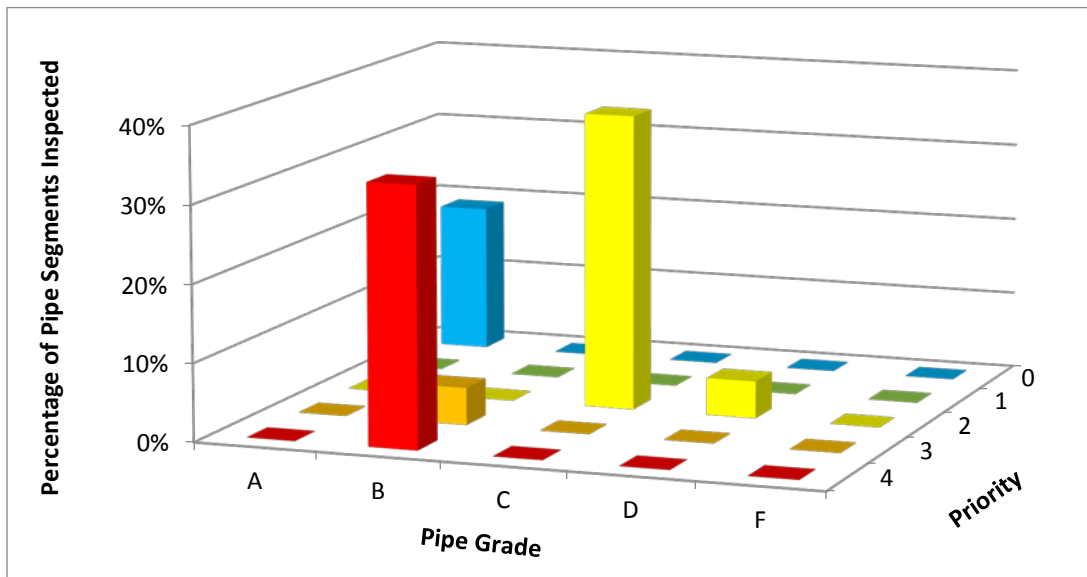
Figure 8
Grade and Priority Summary

Based on the number and degree of defects in each pipe segment, a priority rating was assigned. Table 3 below summarizes the pipe counts for each grade and corresponding prioritization, and Figure 8 displays the results graphically.

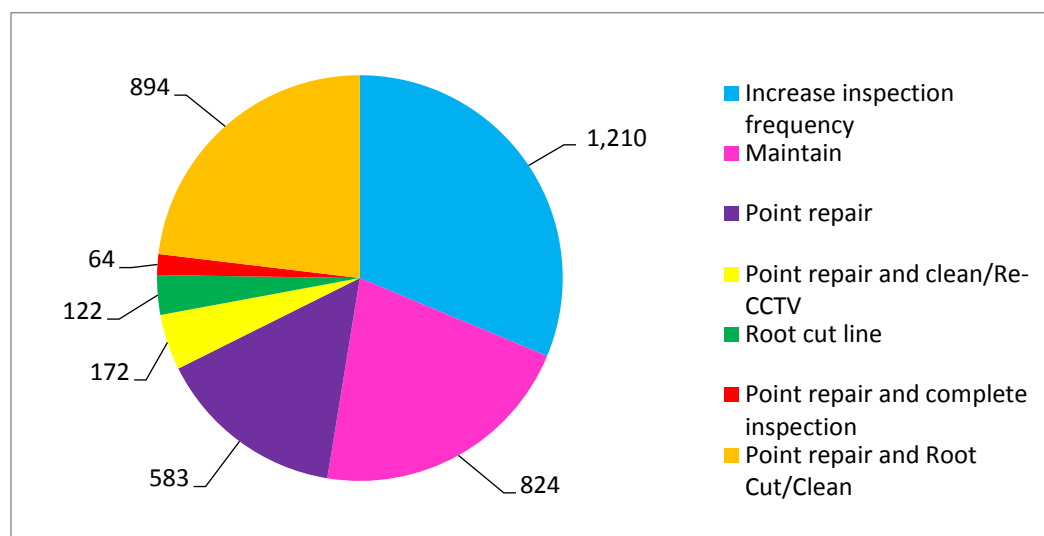
Figure 9
Recommendation Summary

Table 4 and Figure 9 summarize the recommendations for all of the pipe segments inspected in 2016. A complete listing of each pipe segment, and its associated grade, priority, and recommendation may be found in Appendix A.

It is recommended that the Village of Minerva Park implement a pipe line rehabilitation program to repair deficiencies found during CCTV inspection. Improvements have been categorized as Priority 2 or 3. No defects were identified as Priority 1 requiring immediate repair. All pipe line point repairs were identified as Priority 2 and should be scheduled for repair within 1-2 years. Pipe line rehabilitation should include thirteen (13) point repairs on nine (9) pipe lines at an estimated cost of \$188,500. In addition to structural pipe repairs, six (6) pipes require removal of roots, cleaning and completion of CCTV inspection at an estimated cost of \$4,300. Total planning level cost to implement the recommended improvement program is \$192,800. A summary of pipe line improvement cost is shown in Table 5. Detailed recommendations are provided in Appendix A.
