2017 CCTV Inspection Analysis

PREPARED BY: CH2M

DATE: September 29, 2017

PROJECT NUMBER: 690666

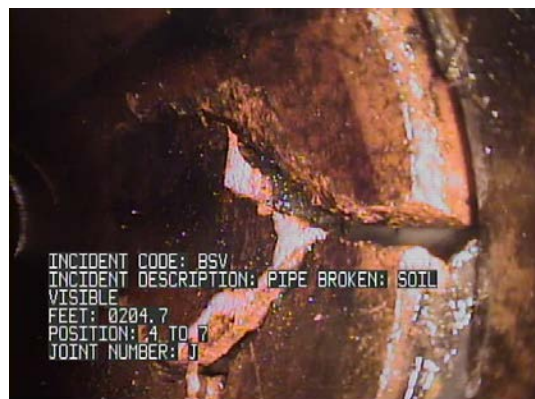
Broken Pipe – One type of structural problem observed was broken pipe segments with visible voids behind the break. A broken pipe section seen during CCTV inspection is shown in Figure 1. Breaks may be the result of excessive loading, improper installation, or pipe deterioration. These defects may allow leakage of raw sewage into the ground and significant inflow of groundwater which may cause sinkholes.

Figure 1
Broken Pipe in Segment MH 033 to MH 032

033	032	8	VCP	262	262	8/9/2017	Hole with soil visible at 44' and 205' from MH 033. Multiple cracks and fractures. Roots at pipe joints throughout.	D	2	Root Cut/Encrustation removal and Line	RC				262	LF	\$45	262	LF	2.50	\$12,445		
034	032	15	VCP	297	297	8/9/2017	Multiple cracks and fractures. Roots at pipe joints throughout.	D	2	Root Cut/Encrustation removal and Line	RC				297	LF	\$75	297	LF	2.50	\$23,018		
048	034	15	VCP	95	95	8/8/2017	Multiple cracks and fractures. Attached deposits throughout.	D	2	Encrustation removal and Line	RC				95	LF	\$75	95	LF	2.50	\$7,363		
070	048	15	VCP	276	276	8/8/2017	Multiple cracks and fractures. Roots at pipe joints throughout. Attached deposits at 3' and 60' from MH 070.	D	2	Root Cut/Encrustation removal and Line	RC				276	LF	\$75	276	LF	2.50	\$21,351		
071	070	12	VCP	389	389	8/8/2017	Multiple cracks and fractures. Broken pipe at 162', 234' and 261' from MH 071. Attached deposits throughout.	D	2	Encrustation removal and Line	RC				389	LF	\$65	389	LF	2.50	\$26,258

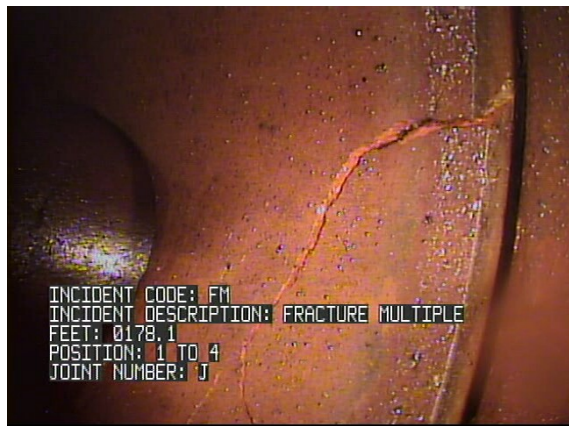
Fractured Pipe – Figure 2 shows a fractured pipe section. Fractures are defects where there is a clear separation between the fragments, but no hole has yet been formed. Like breaks, fractures may be the result of excessive loading, improper installation, or pipe deterioration. Left unabated, fractures can worsen over time to cause pipe deflection and collapse.

Figure 2
Fractured Pipe in Segment MH 018 to MH 005

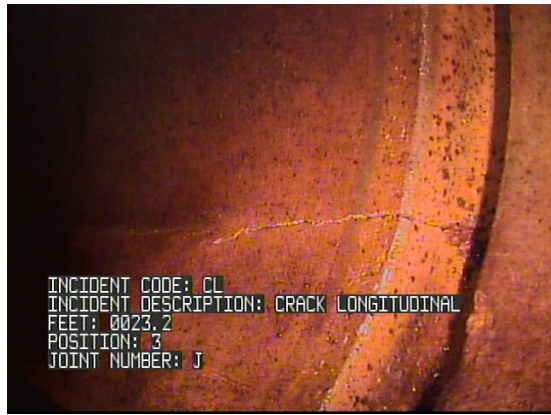
Cracked Pipe – Figure 3 shows a crack in a pipe segment wall. Cracks are less severe than fractures, and do not have visible separation between the pieces. Over time, however, cracks can worsen into fractures and breaks.

Figure 3
Cracked Pipe in Segment MH 021 to MH 019

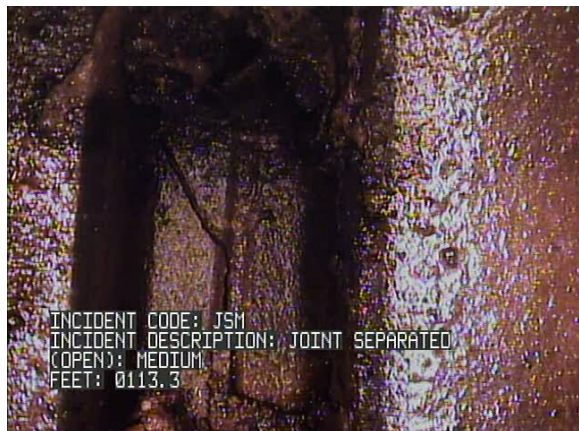
Separated Joints – Offset joints between pipe segments can allow groundwater infiltration to occur, will contribute to uneven stresses on the pipe, and can cause further cracks and damage. This defect is considered structural and is evaluated accordingly. Figure 4 shows an example of a separated joint.

Figure 4
Offset Joint in Segment MH 072 to MH 071

072	071	8	VCP	212	212	8/8/2017	Multiple cracks and fractures. Separated Joint at 113' from MH 072. Attached deposits throughout.	D	2	Encrustation removal and Line	RC				212	LF	\$45	212	LF	2.50	\$10,070		
073	071	12	VCP	148	148	8/8/2017	Multiple cracks and fractures. Broken pipe at 93' from MH 073. Attached deposits throughout.	D	2	Encrustation removal and Line	RC				148	LF	\$65	148	LF	2.50	\$10,017		
074	073	12	VCP	134	134	8/8/2017	Multiple cracks and fractures. Roots at pipe joints throughout.	D	2	Encrustation removal and Line	RC				134	LF	\$65	134	LF	2.50	\$9,011		
											Sub Total	2		5,469			4,276				\$362,947		
ADMINISTRATION ITEMS																							
20% Legal, Administration, and Design																							
25% Contingency																							
Administration Subtotal																							
Total Cost																							
\$526,273

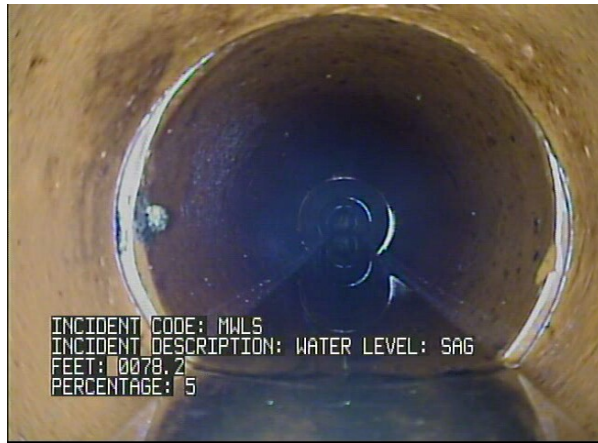
Vertical Alignment Defects – Several vertical alignment defects were recorded during the inspection process. This type of defect creates hydraulic bottlenecks which reduce the system’s hydraulic carrying capacity and causes elevated water levels within the pipe segment. Figure 5 shows flow conditions of a vertical alignment defect.

Figure 5
 Sag in Pipe Segment MH 030 to MH 029

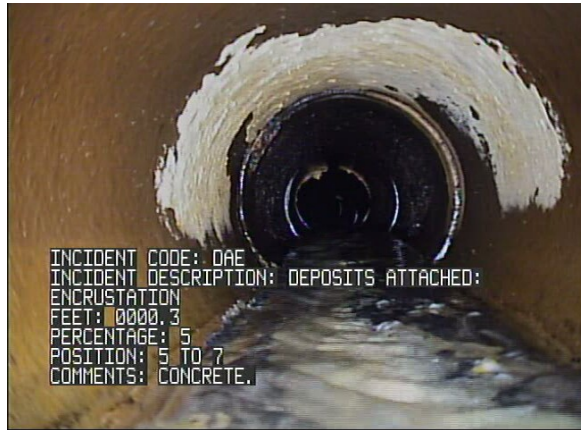
Attached Encrustation – Most pipe segments had light to moderate attached encrustation (DEA) along the pipe walls. The buildup can restrict the flow and reduce hydraulic performance. An example of encrustation buildup along the mainline is shown in Figure 6.

Figure 6
 Deposits Attached in Pipe Segment MH 002 to MH 001

002	001	8	VCP	172	172	8/16/2017	Multiple cracks and fractures. Multiple Roots at joints. Attached deposits throughout.	D	2	Encrustation removal and Line	RC				172	LF	\$45	172	LF	2.50	\$8,170		
003	002	8	VCP	258	258	8/16/2017	Multiple cracks and fractures. Attached deposits throughout.	D	2	Encrustation removal and Line	RC				258	LF	\$45	258	LF	2.50	\$12,255		
004	003	8	VCP		272	8/16/2017	Survey abandoned 181' from MH 003 and 91' from MH 004 due to attached deposits. Multiple cracks and fractures. Attached deposits throughout.	D	2	Encrustation removal and Line	RC				272	LF	\$45	272	LF	2.50	\$12,920		
005	001	18	VCP	245	245	8/10/2017	Longitudinal cracks at 18.5' and 61' and 71' from MH 005. Multiple Roots at joints. Attached deposits throughout.	D	2	Encrustation removal and Line	RC				245	LF	\$95	245	LF	2.50	\$23,888		
018	005	15	VCP	405	405	8/10/2017	Multiple cracks and fractures. Attached deposits throughout.	D	2	Encrustation removal and Line	RC				405	LF	\$75	405	LF	2.50	\$31,388

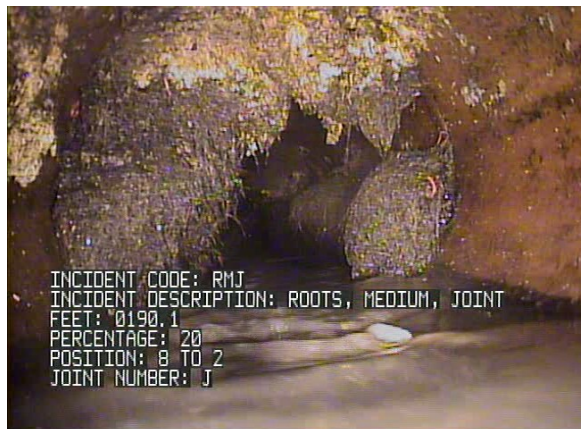
Roots – Another observed problem was light to heavy root intrusion. In some cases, heavy roots impeded the travel of the CCTV camera. Roots are a maintenance problem and must be removed through cleaning and cutting activities or chemical treatment. Roots may also cause structural damage to pipe joints and walls by growing and forcing cracks to open, requiring pipe replacement. Intrusion of roots at joints is shown in Figure 7.

Figure 7
 Root Intrusion in Segment MH 034 to MH 032
