2017 CCTV Inspection Analysis

PREPARED BY: CH2M

DATE: September 29, 2017

PROJECT NUMBER: 690666

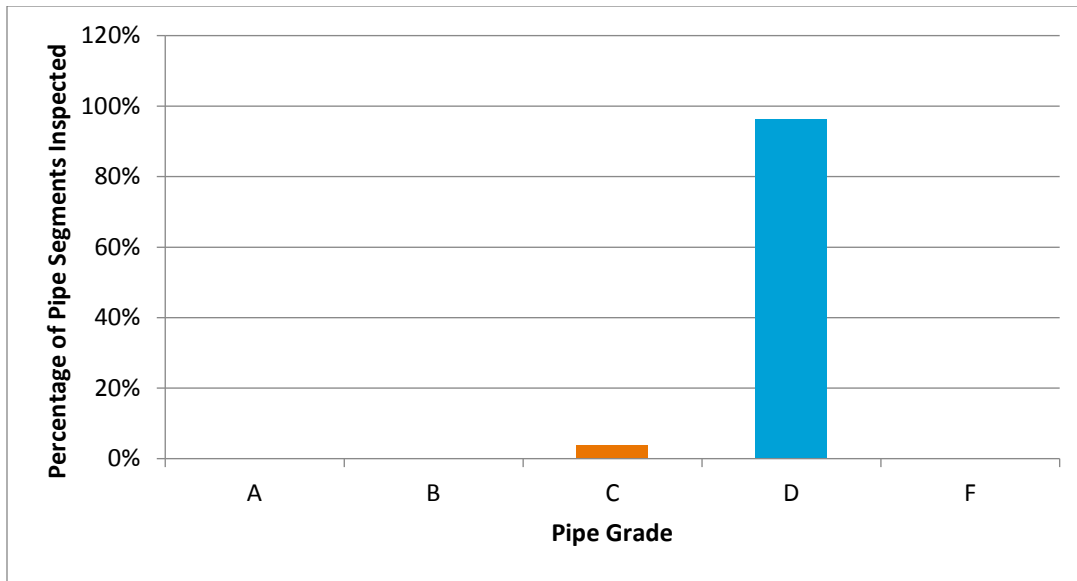
Figure 8
Pipe Grade Distribution

The percentages of pipe segments in each of the condition grades for the pipes inspected in 2017 are listed below. Figure 8 shows the graphical representation of the distribution of the pipe segments based on overall condition grade.

- 0 percent of pipes are in Grade A condition
- 0 percent of pipes are in Grade B condition
- 4 percent of pipes are in Grade C condition
- 96 percent of pipes are in Grade D condition

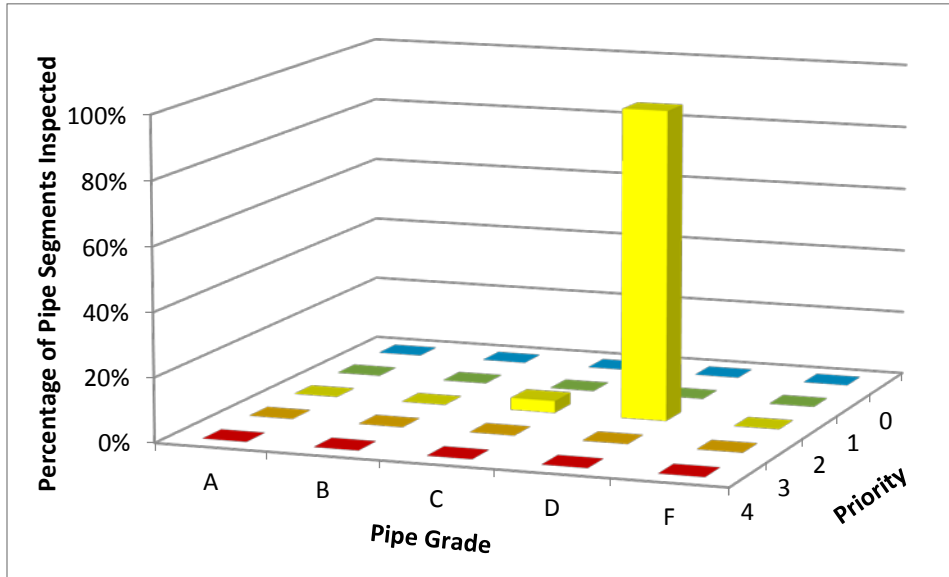
Figure 9
Grade and Priority Summary

Based on the number and degree of defects in each pipe segment, a priority rating was assigned. Table 3 below summarizes the pipe counts for each grade and corresponding prioritization, and Figure 9 displays the results graphically.

Pipe Grade	Priority				
	0	4	3	2	1
A	0	0	0	0	0
B	0	0	0	0	0
C	0	0	0	1	0
D	0	0	0	26	0
F	0	0	0	0	0
TOTAL	0	0	0	27	0

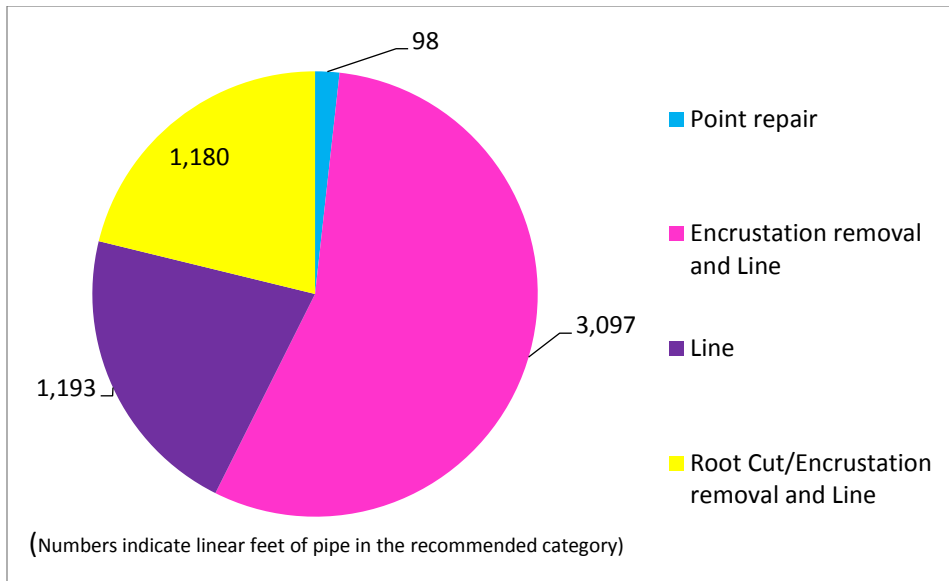
Figure 10
Recommendation Summary

Table 4 and Figure 10 summarize the recommendations for all of the pipe segments inspected in 2017. A complete listing of each pipe segment and its associated grade, priority, and recommendation may be found in Appendix A.

Recommendation	Footage	% Total
Point repair	98	2%
Encrustation removal and Line	3,097	56%
Line	1,193	21%
Root Cut/Encrustation removal and Line	1,180	21%
TOTAL	5,567	100%

It is recommended that the Village of Minerva Park implement a pipe line rehabilitation program to repair deficiencies found during CCTV inspection. Improvements have been categorized as Priority 2 or 3. No defects were identified as Priority 1 requiring immediate repair. All pipe line point repairs were identified as Priority 2 and should be scheduled for repair within 1-2 years. Pipe line rehabilitation should include two (2) point repairs on one (1) pipe lines at an estimated cost of \$20,000, fourteen (14) lines need removal of encrustation and lining at an estimated cost of \$205,700, eight (8) lines need to be lined at an estimated cost of \$53,700, and four (4) lines need root cut with removal of encrustation and lining at estimated cost of \$83,600. Total planning level cost to implement the recommended improvement program is \$526,400. A summary of pipe line improvement cost is shown in Table 5. Detailed recommendations are provided in Appendix A.
